THE MYSTERY BUG

John Dicker, VE3CSJ SKCC 17103

and Gary Johnson, NA6O SKCC 8335

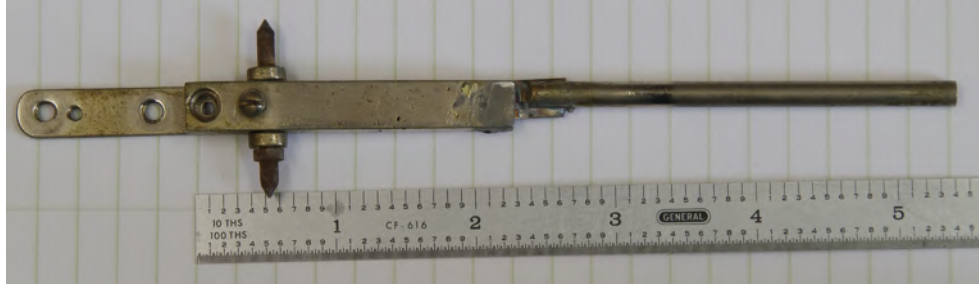
Figure 2. Pendulum assembly, as received.

Unlike many bugs where the main spring is riveted or bolted in place, this one is soldered. As received (Figure 2), it was clear that a repair had been attempted and the spring was soft-soldered in a sloppy fashion. The wreckage was easily disassembled and cleaned for restoration. Based on the mass of the weight rod and the geometry, the spring dimensions of a Vibroplex Original were chosen for the new parts. Both the main spring and dot spring were cut from 12-mil feeler gauge stock and then silver soldered in place (Figure 3). An experiment was performed beforehand to verify that the mechanical properties of the steel were not altered at the soldering temperature (750 C).

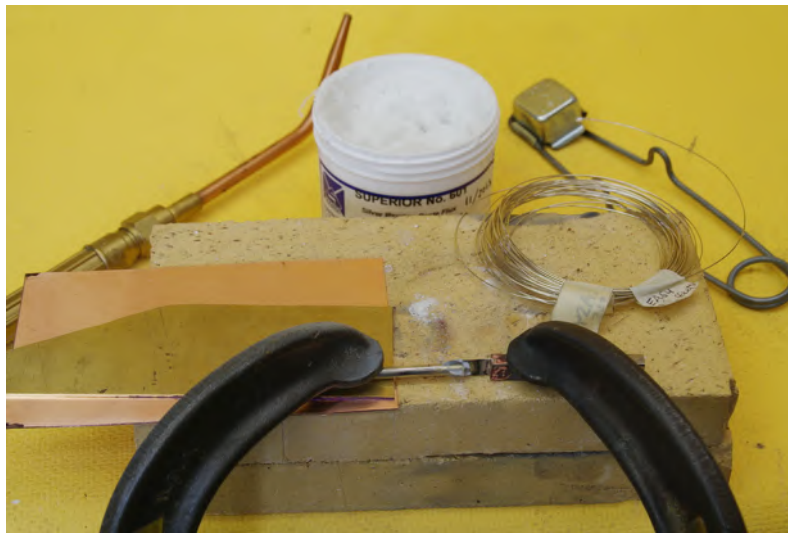
Figure 3. Silver soldering the main spring in a simple fixture.

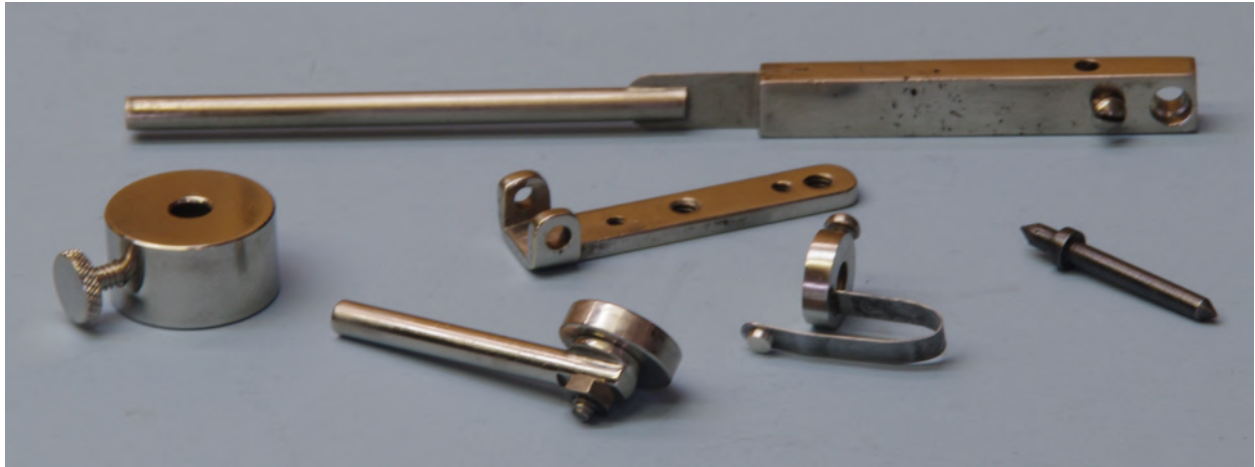
Figure 5. All the parts, ready to ship.

All brass parts were polished and then nickel plated. Original parts of the assembly were not stripped first nor were they re-surfaced, in order to maintain most of the original manufacturing features and flaws. The steel pivot shaft was cleaned and then blued with Brownell's Oxpho Blue. The steps Gary uses for nickel plating are as follows:

1. Final sand with P1200 silicon carbide paper.
2. Power buff as required.
3. Clean and degrease with chlorinated solvent (Brakleen 05089)
4. Activate the surface in 2M sodium hydroxide, about 1 min.
5. De-smut in 5% hydrochloric acid, about 30 sec.
6. Rinse with distilled water.
7. Electroplate in Krohn Bright Nickel solution (2.0 VDC, stirred), about 10 min.
8. Final buff with white rouge.

After a final portrait (Figure 5), all the parts were mailed to John. But would it all fit? Would it work well enough?
