# **RFI Test Report – Tripp-Lite UPS**

# Manufacturer: Tripp-LiteModel: SU1000RTXL2UATested by: Gary Johnson, NA60Date: Nov 25, 2020

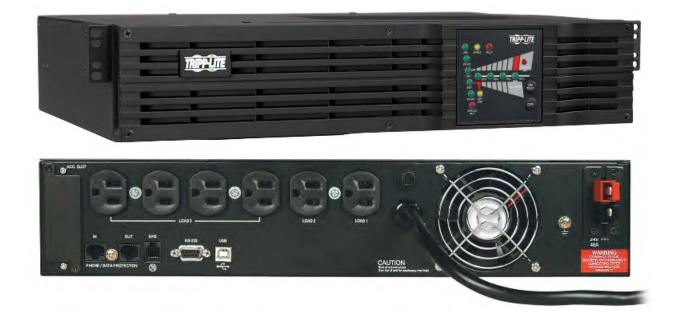
Recommend for amateur radio stations: Conditional. Extensive filtering and choking required FCC Part 15 conducted emissions: Specified as Class A (I did not perform testing) FCC Part 15 labeling: Compliant

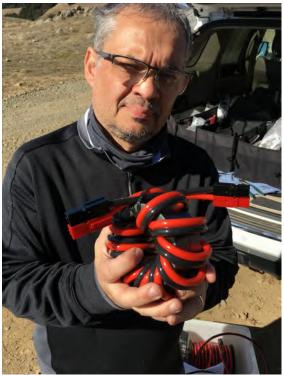
W6TCP holding the high-current battery choke.

Testing proved that the external battery cabling was the source of the radiated noise. Unplugging the battery pack returned everything to the normal baseline noise level. A massive choke was fabricated, consisting of two 4-inch type 31 toroids with 10 turns of #6 AWG paired cable and 75 A PowerPoles. This was plugged into the back of the UPS (very short exposed wire length), then

the batteries were plugged into the choke. Also, excess cable to the batteries was twisted as tightly as possible. This eliminated the severe RFI.

Basic measurements of common-mode current noise were performed with a portable spectrum analyzer and current probe. Installing the large choke reduced the current by at least 25 dB at 3.5 MHz.

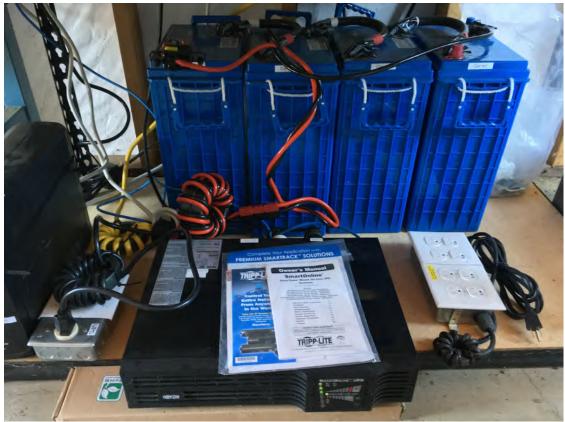
The second UPS installation, with all filtering devices visible.

The second system was installed with its 500-pound (!) external battery set (4 ea Full River DC400-6). This configuration is not something that the manufacturer supports but the owner decided that the large capacity was needed. Comprehensive RFI filtering was preemptively installed, based on experience with the first system:

- Input cord, 12 turns on 4-inch type 31 toroid, followed by a custom outlet box containing a Delta 20DKBG5 EMI filter, followed by a final choke similar to the first.
- Output (load) cords: 8-10 turns on 2.4-inch type 31 toroids plus a custom outlet assembly containing a Delta 03DKAW5 EMI filter.
- Ethernet cable: 14 turns on a 2.4-inch type 31 toroid.
